CONTINUING ELIGIBILITY INSPECTION (CEI) REPORT FOR FLOOD CONTROL WORKS (FEDERAL)

1. Project Name: Hanapepe River FCP

2. Date of Inspection: December 19, 2005

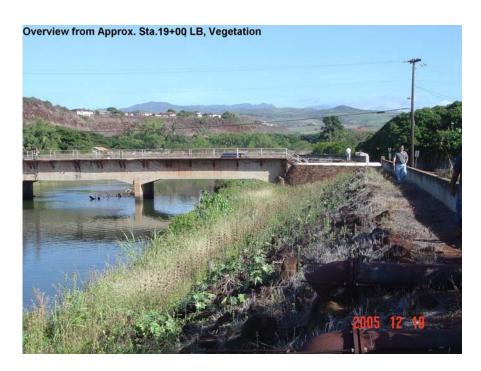
a. Sta. 19+00, LB, Overview

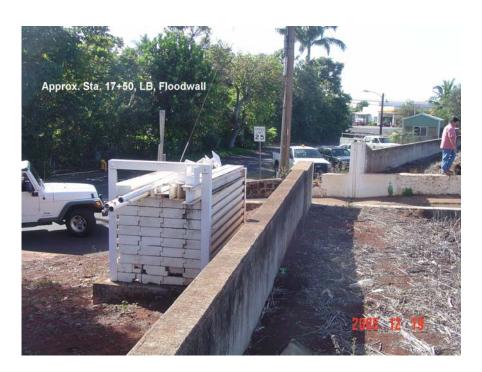
b. Sta. 17+50, LB, Floodwall

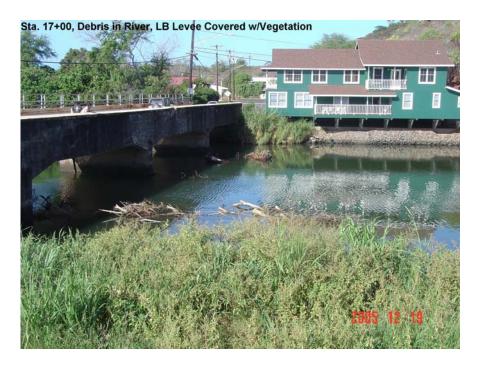
c. Sta. 17+00, Trees in river, vegetation.

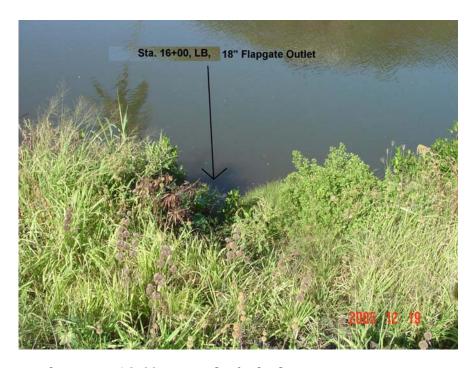
d. Sta. 16+00, LB, Blocked Flapgate.

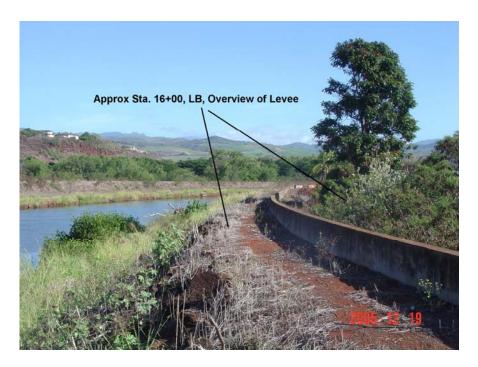
e. Sta. 16+00, Overview of vegetation and armor stone.

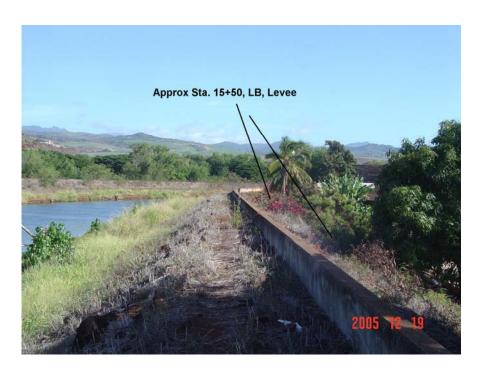
f. Sta. 15+50, LB, Overview of vegetation on both sides of levee. $\,$

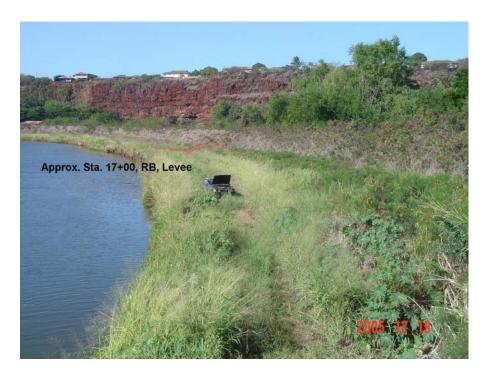
g. Sta. 17+00, RB, Abandon vehicle.

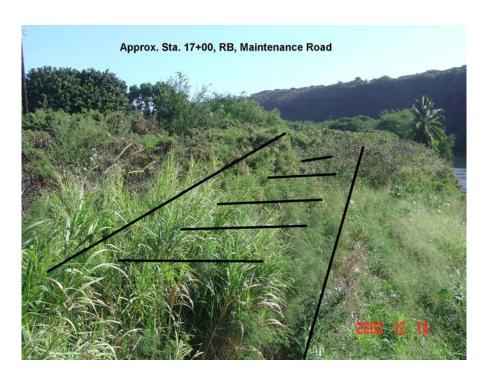
h. Sta. 17+00, RB, overview of maintenance road.
